# MGM Brakes

## TECHNICAL BULLETIN

### SUBJECT: CAUSES OF NON-PRESSURE CHAMBER FAILURES AND RECOMMENDED CORRECTIVE ACTION

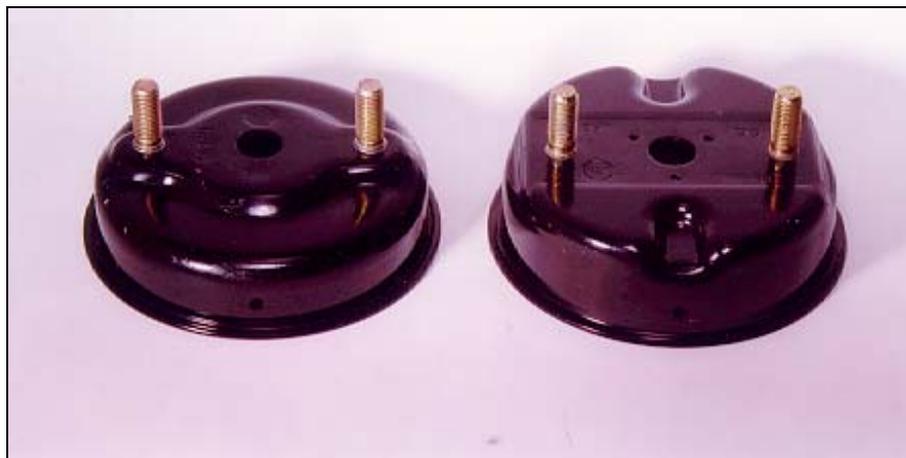
MGM Brakes manufactures two basic non-pressure chambers; a double lobed design (figure 1) used for OEM power vehicle applications with the mounting bolts secured to the bracket vertical to the axle and a flat bottom design (figure 2) used for OEM trailer applications with the mounting bolt secured to the bracket horizontal to the axle. The flat bottom design with reinforcing pads is used for all aftermarket part numbers.

MGM Brakes has been very successful in eliminating non-pressure chamber/mounting bolt failures on **severe service** applications with our unique welded in reinforced pads and mounting bolts in the flat bottom non-pressure chamber. This combination of welded components is applicable to trucks, busses, trailers, and off-highway vehicles.
