FAST BRAKE

TROUBLE-SHOOTING GUIDE

MGM Brakes

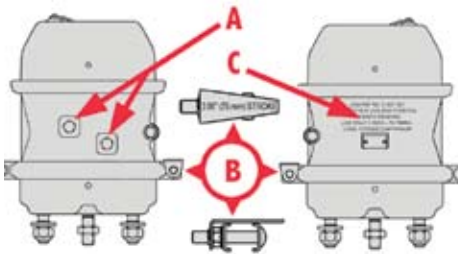
1. All 3-inch “long stroke” chambers can be easily identified by their square air-inlet ports (A), trapezoidal I.D. tags (B) and servicing instructions embossed into the aluminum center case (C).

Trucks, tractors and trailers are being manufactured with both standard 2.5-inch stroke and 3-inch long stroke spring brakes and service chambers, so it is important to know how to identify what is on your equipment.

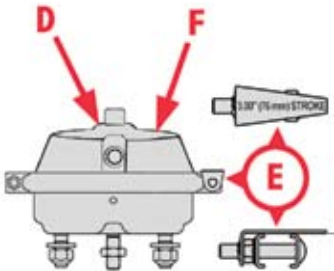
2. Long stroke service chambers are identified by a ½-inch high square raised embossment on top of the pressure cap (D), along with the trapezoidal I.D. tag (E) and embossed instructions on the pressure cap (F).

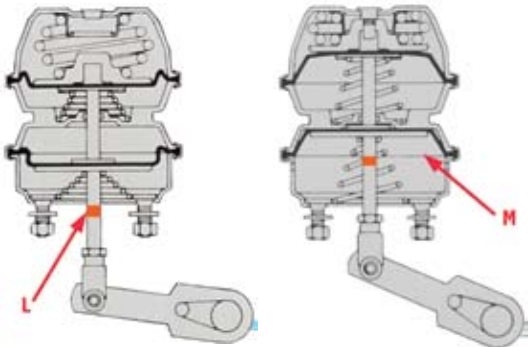
With brakes applied, check the brake chamber piston rod to see if the orange MGM Stroke Alert stripe is showing (L). If so, readjust the slack adjuster in accordance with its manufacturer’s instructions. Be certain that the spring parking brake chamber is fully released during this adjustment.

2. Available air pressure to brake chamber insufficient (M).

The angle made by the brake actuator push rod with respect to the mounting surface should be perpendicular within $+3^\circ$ from zero to full stroke. The rod clearance hole (N) in the non-pressure chamber (mounting base) for the brake actuator push rod should not be elongated or show evidence of rubbing from the rod.

With brakes applied, using 80/90 P.S.I., the angle (O) between the push rod and slack adjuster should never be less than 90° . Consult the slack adjuster manufacturer's literature for proper operation and set-up.

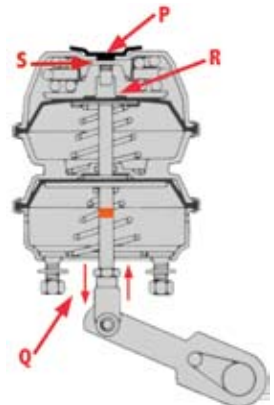
Remove the end plug from the release bolt access hole of the brake chamber (P). Use a flashlight to check for evidence of spring breakage.

Brake chamber stroke (Q) can also be checked while applying and releasing the parking brake. If the expected range of motion is not observed, the spring may be broken. Also, the contents will rattle if the piggyback is removed and shaken, indicating a probable broken spring.

Replace with appropriate MGM piggyback.

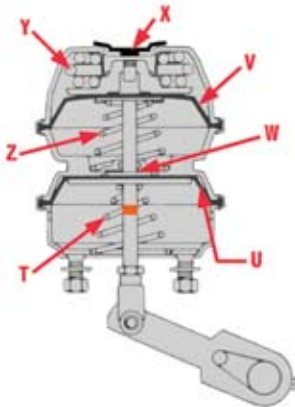
- 5. Ruptured diaphragm (V) or damaged push-rod seal (W).**

Check for leakage at the parking chamber vent holes or

through the release bolt hole. Remove the release bolt access hole end cap (X) and apply air to spring brakes (release). If you feel or hear air escaping in these areas, the diaphragm is defective.

- 3. The spring brake piston (R) is binding before the piston is fully retracted.**

Release the parking brake. (Remove the end plug (P) and apply 90-100 P.S.I. air pressure.) Look into the end plug hole to see if the top of the piston is approximately .200 inches from the head. If not, replace the single/piggyback with a MGM piggyback or piggyback plus kit.

- 4. Broken return spring in the service chamber (T).**

Remove piggyback and service diaphragm (U) and inspect the return spring (T). If broken, replace with a new return spring and new diaphragm. Order only genuine MGM brand replacement parts and install in accordance with the appropriate MGM Brakes Service Manual instructions.

If air applied to the spring chamber has a tendency to apply the service brake, or to cause the service exhaust valve to leak, the push rod seal is leaking (W). (To verify, remove the service air line and apply air to the parking chamber. If air is detected coming through the open service air port, the push-rod seal is leaking.) Replace the entire piggyback as instructed in the appropriate MGM Brakes Service Manual.

7. Broken power spring (Y) or return spring (Z) in parking brake section.

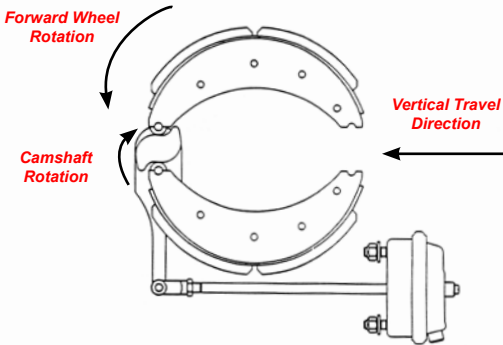
Cam Rotation Opposite Wheel

These “symptoms” are usually associated with “reverse” cam rotation, or s-cam rotation opposite of the forward rotation of the wheel. The “vibration” generated by this foundation brake arrangement is most noticeable in the leading shoe, which, due to the rotation of the wheel away from the drum, forces the cam to rotate backwards, resulting in a “chattering” sound. This rapid back and forth movement of the cam is amplified when the “natural” frequency (vibration) of the complete system: i.e. foundation brake, push rod, brake actuator and suspension; is at, or near, its resonate frequency.

If the linings, camshaft bushings and other component parts are worn, replacement may temporarily correct, or quiet, the problem.
