Self-Study Training Program

Servicing Spring Brakes

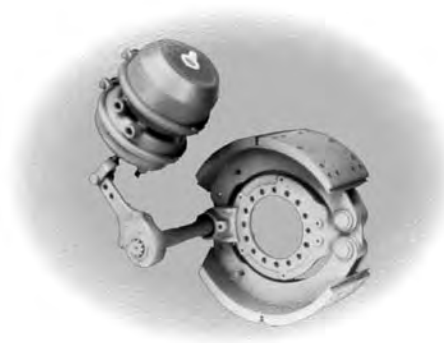
Figure 2

Cam brakes represent the most commonly used foundation brake on heavy-duty commercial vehicles today (**Fig. 2**). Cam brakes operate through the action of the brake chamber, which is attached to a bracket mounted to the foundation brake. The brake chamber operates on compressed air supplied through the service port to the top of the service diaphragm. When compressed air enters the service chamber, the service diaphragm is forced downward against the service piston. The service piston is linked to the foundation brake by the piston push-rod, which is connected to a manual or automatic slack adjuster by a yoke. The slack adjuster is attached to the camshaft, and when the push-rod is forced outward, the slack adjuster transforms the movement, which is linear force, into a twisting, or rotating

force, or torque. The torque applied to the end of the camshaft causes the “S” cam on the other end to rotate, spreading the brake shoes. This forces the brake linings out against the drum, slowing the vehicle.

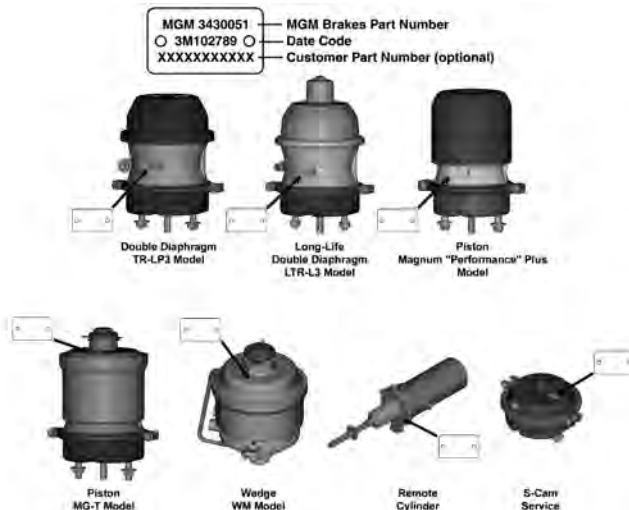
Figure 9

All MGM brake actuators made after October, 1987 have an aluminum identification tag attached to the actuator that has the MGM Brakes part number, date of manufacture, and often a customer part number clearly stamped on it. Refer to the adjacent illustration for the location of the I.D. tag on the various models manufactured by MGM Brakes (**Fig. 9**).

MGM Brakes actuators are assigned a seven (7) digit part number that begins with a 1, 2, 3, 4 or 5, depending on the model, except for the magnum models that begin with the letter M: example: MJS, MJW and/or MJB.

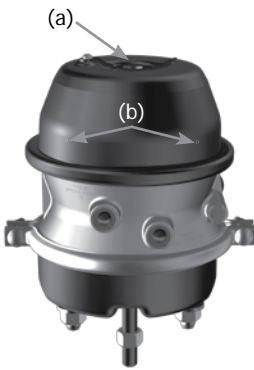
Figure 11a & b

The first thing you want to inspect is the plastic END CAP or DUST PLUG (**Fig. 11a**). Make sure it is not damaged and that it is snapped tightly in-place, and, if it is designed to be attached to the head, it is securely attached. While these caps/plugs require no special positioning or maintenance, they must be snapped tightly into the release bolt access hole to prevent ingestion of large particles of contamination, such as grit and gravel. Failure to properly install the cap/plug can adversely effect the warranty on some models of spring brakes such as MGM Brakes models equipped with the external breather-tube. The END CAP on MGM Brakes TR-T and TR-TS model brakes are equipped with a rubber O-ring (**Fig. 12**) to help seal out moisture. Ensure the O-ring is free of damage and is properly positioned on the END CAP.

Be sure to inspect the VENT HOLES (**Fig. 11b**) in the head of the spring brake to ensure they are fully open and unrestricted. Brakes need to “breathe” when operating. When installed on vehicles operating in dump truck, ready-mix concrete and other similar operations, spring brakes can become encrusted with dirt or concrete which can prevent the circulation of air through the unit and entrap moisture and contaminants. If the holes are restricted, carefully ream the holes out by hand with a 3/8-inch drill bit (**Fig. 13**).

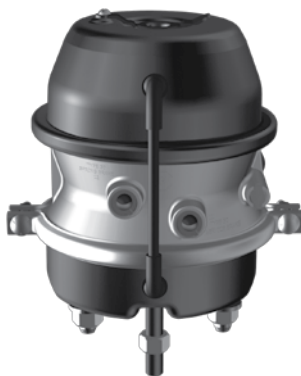
Figure 14

On units equipped with an EXTERNAL BREATHER-TUBE (**Fig. 14**), be sure to inspect the breather-tube and elbows for damage. Make sure the BREATHER-TUBE is inserted a minimum of 1/2-inch into each elbow and securely fastened with a high quality rubber adhesive or clamp.

NOTE: IMPORTANT - When installing any MGM Brakes model with the breather tube, it is mandatory to position the breather tube in the upper half, or upper quadrant (9:00 to 3:00 o'clock), facing away from the road surface (Fig. 15). Failure to comply will void the MGM Brakes Warranty without remedy on these models.

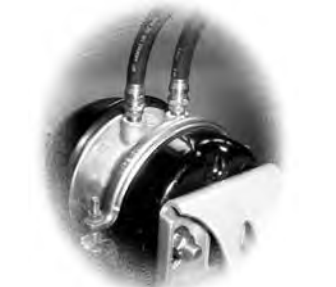
Figure 19

Carefully inspect all air lines, hoses and fittings attached to the chamber (**Fig. 19**). Remove and replace any damaged or leaking parts. Remember, never disconnect any air hose or air line that contains air pressure as it may "whip" as the air escapes. Never remove a component or pipe plug unless you're absolutely sure that all system pressure has been depleted. Be careful to never exceed recommended air pressures. Always wear safety glasses while working with pressurized air and never look directly into air jets or direct them at anyone.

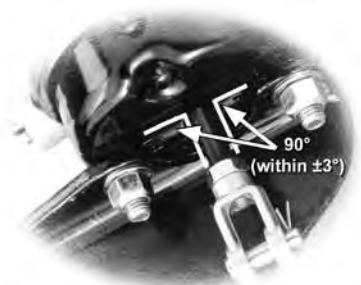
Figure 20

Inspect the PUSH-ROD (**Fig. 20**) to be sure it is working freely, that it is not bent or binding, and is square to the chamber bottom within $\pm 3^\circ$ in any direction and at any point during the stroke of the chamber. If the PUSH-ROD is not square, make corrections by repositioning the chamber on the mounting bracket or by shimming the slack adjuster to the right or left of the camshaft as required.

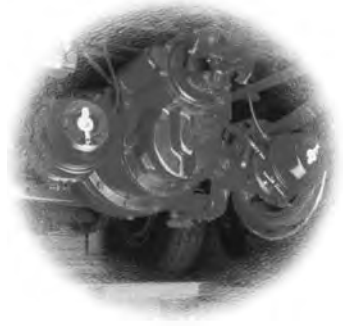
Figure 23

And finally, before you come out from under the vehicle, visually inspect the foundation brake (**Fig. 23**) to make sure there are no loose, missing or broken mechanical components. Many commercial vehicles are placed "out-of-service" by *Commercial Vehicle Safety Alliance (CVSA)* inspectors for the following, highly visible problems:

1. Absence of effective braking action when air is applied to the service brakes, i.e. brake linings failing to move or contact the drum.
2. Missing or broken components such as brake shoes, brake drums, anchor pins and spiders.
3. Cracked, loose or missing brake lining or pads.
 - a. Lining cracks or voids 1/16-inch in width observable on the edge of the lining.
 - b. Portions of the lining segment missing so that a rivet or bolt is exposed when viewing the lining from the edge.
 - c. Loose lining segments with approximately 1/16-inch movement.
 - d. Complete lining segment missing.
4. Evidence of oil seepage onto or out of the brake lining or drum area. This includes wet contamination of the lining edge accompanied by evidence that further contamination will occur, such as oil running from the drum or bearing seal.

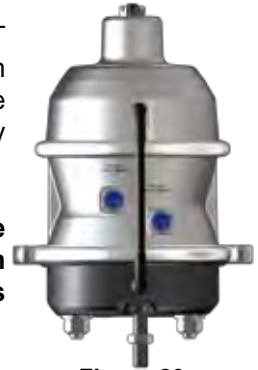
Figure 29

For MGM brakes equipped with an INTEGRAL RELEASE BOLT (Fig. 29), i.e. models LTR-T and LTR-L3, use a 15/16-inch wrench (DO NOT USE AN IMPACT-TYPE WRENCH) to turn the RELEASE BOLT counter-clockwise until the power spring is fully caged (Fig. 30).

WARNING: DO NOT exceed any of these recommended lengths, and DO NOT exceed 50 Lbs.-Ft. of torque on the RELEASE NUT at any time or you may damage the RELEASE BOLT or other internal components which could prevent correct manual-release of the chamber.

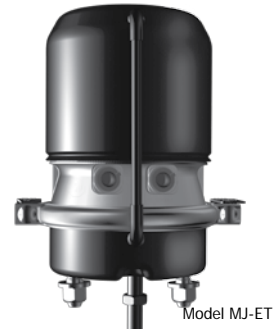
Figure 31

NOTE: With MGM Brakes “Magnum” piston-type brakes, models MG-T and MJ-ET (Fig. 31), the spring brake is manually released by turning the release bolt counter-clockwise using a 3/4-inch deep socket wrench. The release bolt can be completely removed on MG-T models. However, MJ-ET units have a non-removable release bolt. Use the following recommendations when manually releasing MJ-ET models:

<u>Brake Stroke</u>	<u>Release Bolt Protrusion</u>
2.50" (Std.) Stroke	1.07"
3.00" (Long) Stroke	1.27"

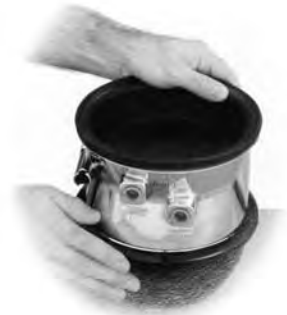
Figure 37

Before installing the new single/piggyback spring brake, make sure it is fully released to zero stroke. Now, position the new diaphragm into the bottom recess of the single/piggyback chamber (**Fig. 37**).

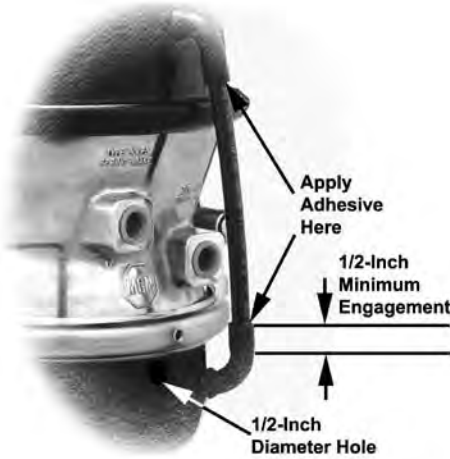
Figure 39

If the new unit is equipped with an EXTERNAL BREATHER-TUBE, insert the end of the tube into the flexible rubber elbow extending from the NON-PRESSURE HOUSING to a minimum 1/2-inch engagement. Secure the tube in place using the hose clamps furnished with the unit, or, wipe the open end of the tube to be sure that no oil is present and apply a high quality rubber adhesive to the tube before inserting it into the rubber elbow (**Fig. 39**).

Remove any metal burrs from around the newly drilled hole, and then install a new rubber elbow on the non-pressure chamber. Again, wipe the open end of the connector tube clean to be sure no oil is present, apply a high quality rubber adhesive to the end of the tube, and insert the tube into the flexible elbow to a minimum 1/2-inch engagement (**Fig. 39**).

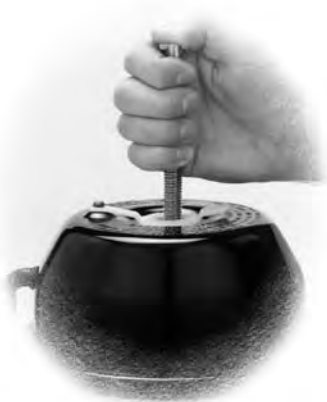
Figure 41

Now, exhaust the air pressure from the service chamber, but maintain line pressure in the spring brake. Remove the **RELEASE BOLT**. Snap the plastic **END CAP** or **DUST PLUG** tightly into the release-bolt access hole. Use the **RELEASE BOLT** to press the **END CAP** securely into place (**Fig. 41**). Install the **RELEASE BOLT**, **NUT** and **WASHER** into their storage pocket (**Fig. 42**) on the side of the chamber (or put them into the vehicle tool box or glove box). Tighten the **RELEASE NUT** against the flat **WASHER** to 10 Lbs.-Ft. torque. If the spring brake chamber is equipped with an integral release bolt (**Fig. 29**), use a 15/16-inch wrench (**DO NOT USE AN IMPACT WRENCH**) and simply turn the release bolt clockwise until the bolt is fully engaged into the unit and the slotted nut bottoms out. Tighten the nut to 45-50 Lbs.-Ft. of torque.

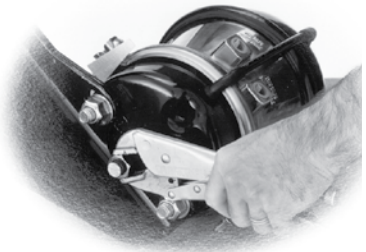
Figure 44

To begin with, make sure the wheels of the vehicle have been securely chocked (or blocked) to prevent the vehicle from moving. Now, manually (or with system air pressure) extend the service push-rod slightly and clamp it in place with vise-grip pliers to prevent sudden separation of the single/piggyback from the service chamber when the clamp band is removed (Fig. 44).

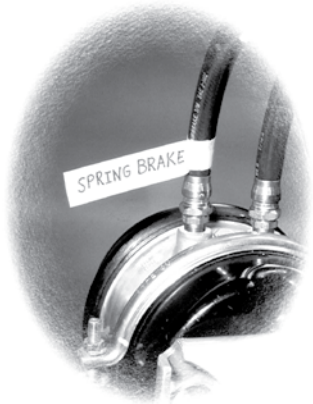
Figure 45

Next, should you decide to remove the SERVICE and SPRING BRAKE supply lines from the single/piggyback chamber, be sure to mark the air line connected to the inlet port marked “SPRING BRAKE” (Fig. 45). This way it can be easily identified and properly connected to the correct inlet port during the reinstallation process. If the brake is equipped with an EXTERNAL BREATHER-TUBE, disconnect the tube from the rubber elbow (Fig. 46). Because the tube is bonded to the rubber elbow by a rubber adhesive, it may be necessary to “roll” the rubber elbow away from the tube to achieve separation.

Next, remove both air supply lines from the assembly, making sure to note which air line was connected to the inlet port marked "SPRING BRAKE". This is important for later reinstallation reference. Masking tape and a felt-tip marker are handy for this purpose (**Fig. 45**).

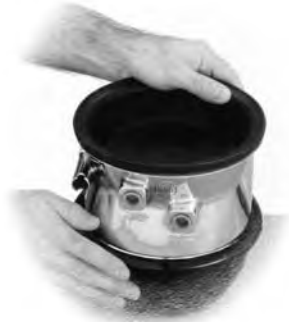
Figure 48

Place a new diaphragm into the cavity of the single/piggyback chamber flange case (**Fig. 48**) and align the single/piggyback with the non-pressure chamber.

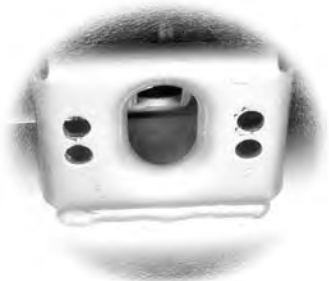
Figure 57

Remove the hex nuts and the flat washers from the mounting bolts of the new chamber. Prior to installing the new combination/tandem brake, take a few minutes to inspect the mounting bracket to insure the bracket surface is free of all cracks, burrs and debris that may prevent the brake from mounting flush to the bracket's surface (Fig. 57).

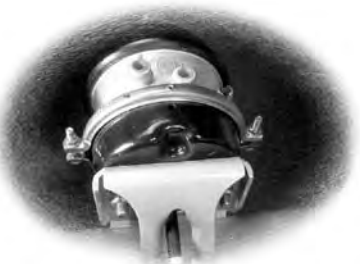
Figure 58

Now, install the new chamber on the bracket, paying close attention to positioning the chamber air inlet ports for correct alignment to the vehicle air supply lines (Fig. 58). **Make sure you mount the brake directly to the bracket. DO NOT use any spacers, washers or shims between the mounting bracket and the non-pressure housing.** Install one flat washer and hex nut on each mounting bolt, and, using a 15/16-inch hand wrench (**DO NOT USE AN IMPACT-TYPE WRENCH**), tighten the nuts to the MGM Brakes recommended 133-155 Lbs.-Ft. of torque (Fig. 59).

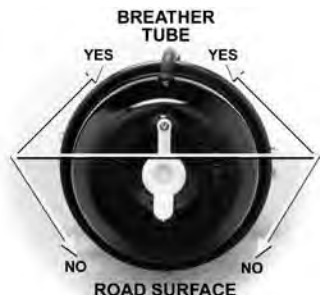
Figure 60

NOTE: IMPORTANT - When installing any MGM Brakes model with the breather tube, it is mandatory to position the breather tube so that it faces away from the road surface (Fig. 60). Failure to comply will void the MGM Brakes Warranty without remedy on these models.

NOTE: IMPORTANT - When installing any MGM Brakes model with the breather tube, it is mandatory to position the breather tube in the upper half, or upper quadrant (9:00 to 3:00 o'clock), facing away from the road surface (Fig. 60). Failure to comply will void the MGM Brakes Warranty without remedy on these models.

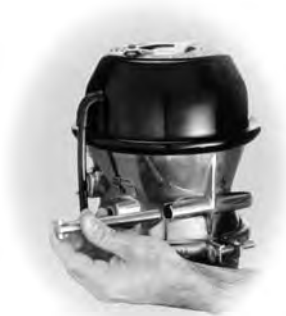
Figure 67

Next, place the release bolt, nut and washer securely into the storage pocket (Fig. 67) on the chamber. Tighten the nut against the flat washer to 10 Lbs.-Ft. of torque (Fig. 68). The release bolt can also be stored in the vehicle toolbox or glove box. Be sure to completely exhaust the air from both sides of the chamber when finished.

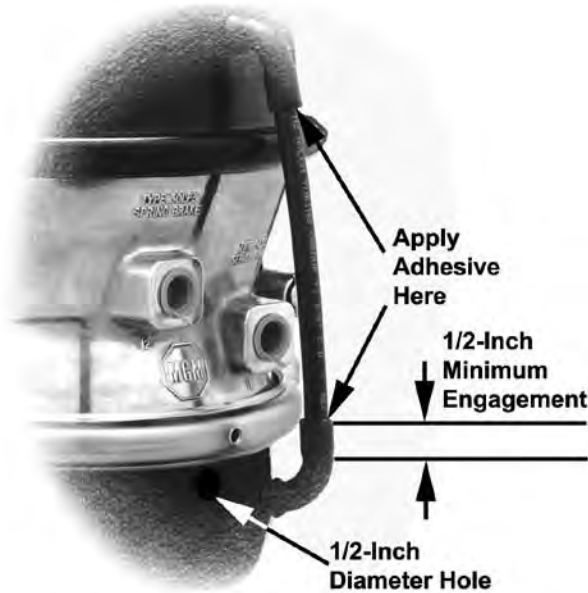
Figure 69

If the chamber is fitted with an external breather tube, be sure both ends of the tube are engaged a minimum of 1/2-inch into each of the flexible rubber elbows (**Fig. 69**). The tube must be securely fastened into both elbows, either by applying a high-quality rubber adhesive or with hose clamps.

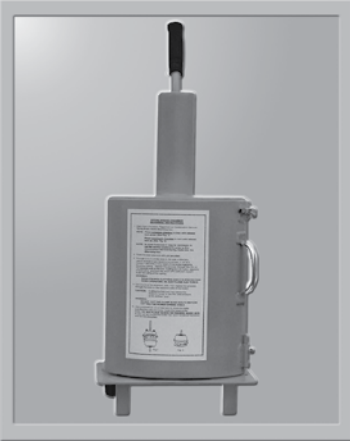
Figure 70

Place the single/piggyback or combination/tandem unit in a properly constructed steel container* (Fig. 70). The container must have openings to expose the head where it is to be cut with an acetylene gas torch. It must also be strong enough to prevent parts from hurtling out should the unit suddenly separate before it is safely disarmed.

The proper disposal of old spring brake chambers is a concern of every fleet maintenance department and repair shop throughout the industry. All retired spring brake actuators must be safely disarmed before they are disposed of to prevent serious personal injury from accidental sudden release of the high-energy spring (as much as 2700 lbs. of force) in the parking chamber.

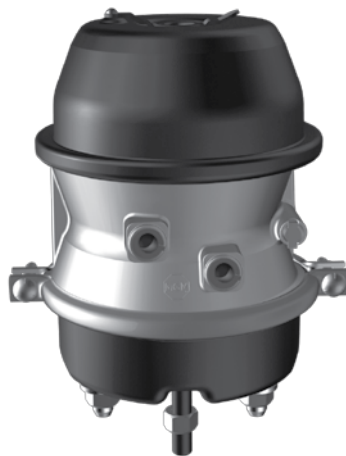
Figure 76

Elevated brake temperatures are a major factor in the loss of braking effectiveness. We have seen how stopping distances were adversely affected by the increase in stroke caused by improper brake adjustment. Now, consider the increase in stroke brought on by the heat-induced expansion of the brake drum. If the temperature of the drums on the same test vehicle were raised to a realistic operating temperature of 600° F, the stopping distance would increase to approximately 692 feet, even though the brakes were adjusted to the CVSA limit.

You can see that even though the brakes were technically “in adjustment”, the influence of heat on the chamber stroke, in conjunction with normal brake lining fade, more than doubled the stopping distance. That is why 3-inch “Long Stroke” brakes (**Fig. 76**) have become one of the hottest topics in the trucking industry today. The bottom line for the use of “Long Stroke” brakes is safety. Even with proper maintenance and the incorporation of automatic slack adjusters, vehicles equipped with standard (2.5-inch) stroke chambers can still suffer a loss in braking performance. MGM Brakes, along with the American Trucking Association, the National Highway Traffic Safety Administration (NHTSA) and other industry leaders have worked very closely with CVSA on the “Long Stroke” concept.

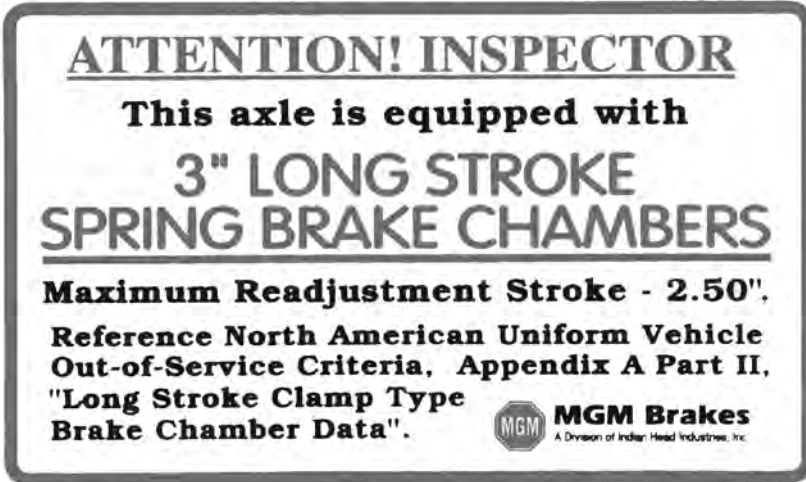
Figure 78

To identify that a vehicle is fitted with 3-inch Long Stroke spring brakes, MGM Brakes has made available an identification decal (**Fig. 78**). This decal should be affixed to both sides of the vehicle's frame rail forward of the first drive axle so that it is visible to the inspecting officer. If the vehicle is not equipped with the decals, they can be obtained by contacting MGM Brakes.
