Self-Study Training Program

Servicing Spring Brakes

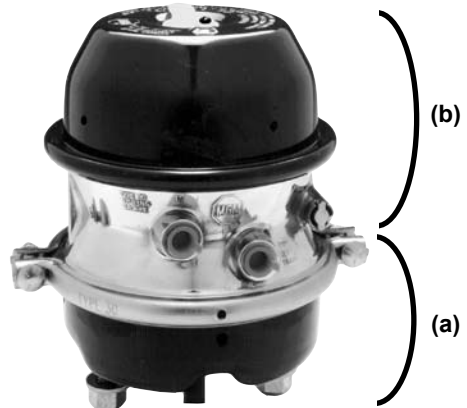
Figure 6

The spring brake has two chambers:

- A. The service brake chamber (**Fig. 6a**) performs the normal slowing and stopping function.
- B. The parking/emergency brake or “piggyback” chamber (**Fig. 6b**), mounted in tandem on top of the service brake chamber, contains a diaphragm (or piston) and a large powerful spring.

The service brake chamber (**Fig. 5, 6a**) functions independently of the spring brake chamber and provides stopping power for the vehicle during normal operation when full air pressure is available. When the brake pedal is depressed, compressed air fills the chamber. When this occurs, the influx of compressed air pushes against the diaphragm, simultaneously compressing the return spring and extending the push-rod. Since the push-rod is connected via a yoke and slack adjuster to the vehicle's foundation brake, whether drum or disc, the result is a gradual slowing of the vehicle dependent upon the amount of air pressure (force) that is applied to the diaphragm.

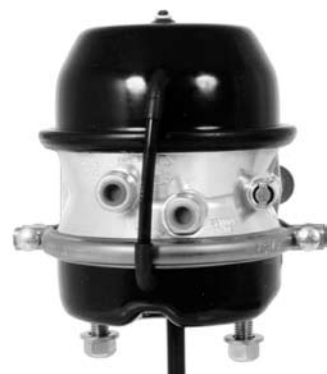
Figure 14

On units equipped with an EXTERNAL BREATHER-TUBE (**Fig. 14**), be sure to inspect the breather-tube and elbows for damage. Make sure the BREATHER-TUBE is inserted a minimum of 1/2-inch into each elbow and securely fastened with a high quality rubber adhesive or clamp.

NOTE: IMPORTANT - When installing any MGM Brakes model with the breather tube, it is mandatory to position the breather tube in the upper half, or upper quadrant (9:00 to 3:00 o'clock), facing away from the road surface (Fig. 15). Failure to comply will void the MGM Brakes Warranty without remedy on these models.

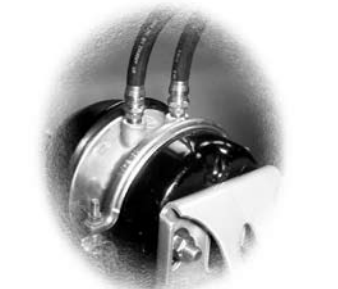
Figure 19

Carefully inspect all air lines, hoses and fittings attached to the chamber (**Fig. 19**). Remove and replace any damaged or leaking parts. Remember, never disconnect any air hose or air line that contains air pressure as it may "whip" as the air escapes. Never remove a component or pipe plug unless you're absolutely sure that all system pressure has been depleted. Be careful to never exceed recommended air pressures. Always wear safety glasses while working with pressurized air and never look directly into air jets or direct them at anyone.

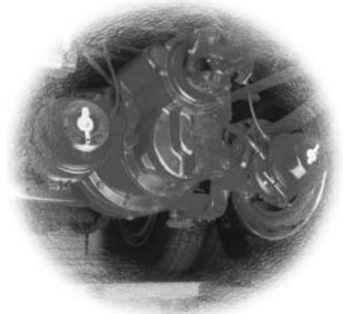
Figure 23

And finally, before you come out from under the vehicle, visually inspect the foundation brake (**Fig. 23**) to make sure there are no loose, missing or broken mechanical components. Many commercial vehicles are placed "out-of-service" by *Commercial Vehicle Safety Alliance (CVSA)* inspectors for the following, highly visible problems:

1. Absence of effective braking action when air is applied to the service brakes, i.e. brake linings failing to move or contact the drum.
2. Missing or broken components such as brake shoes, brake drums, anchor pins and spiders.
3. Cracked, loose or missing brake lining or pads.
 - a. Lining cracks or voids 1/16-inch in width observable on the edge of the lining.
 - b. Portions of the lining segment missing so that a rivet or bolt is exposed when viewing the lining from the edge.
 - c. Loose lining segments with approximately 1/16-inch movement.
 - d. Complete lining segment missing.
4. Evidence of oil seepage onto or out of the brake lining or drum area. This includes wet contamination of the lining edge accompanied by evidence that further contamination will occur, such as oil running from the drum or bearing seal.

NOTE: Grease on the lining edge, back of shoe or drum edge and oil stains with no evidence of fresh oil leakage are not conditions for out-of-service consideration.

5. Any lining with a thickness less than 1/4-inch, or to wear indicator if lining is so marked, measured at the shoe center for drum brakes or less than 1/8-inch for disc brakes.
6. Absence of effective braking action on any steering axle of any vehicle required to have steering axle brakes, including the dolly and front axle of a full trailer.
7. Mismatch of chamber size or slack adjuster length across any power unit steering axle.

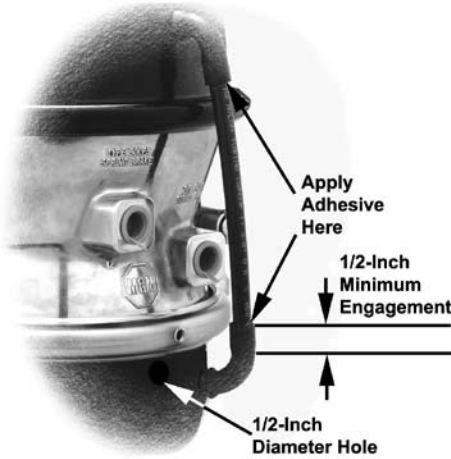
Figure 39

If the new unit is equipped with an EXTERNAL BREATHER-TUBE, insert the end of the tube into the flexible rubber elbow extending from the NON-PRESSURE HOUSING to a minimum 1/2-inch engagement. Secure the tube in place using the hose clamps furnished with the unit, or, wipe the open end of the tube to be sure that no oil is present and apply a high quality rubber adhesive to the tube before inserting it into the rubber elbow (**Fig. 39**).

Remove any metal burrs from around the newly drilled hole, and then install a new rubber elbow on the non-pressure chamber. Again, wipe the open end of the connector tube clean to be sure no oil is present, apply a high quality rubber adhesive to the end of the tube, and insert the tube into the flexible elbow to a minimum 1/2-inch engagement (**Fig. 39**).

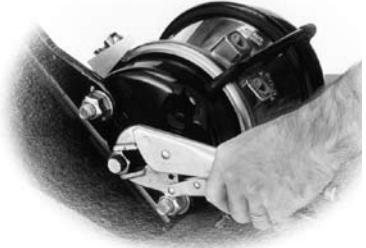
Figure 44

To begin with, make sure the wheels of the vehicle have been securely chocked (or blocked) to prevent the vehicle from moving. Now, manually (or with system air pressure) extend the service push-rod slightly and clamp it in place with vise-grip pliers to prevent sudden separation of the single/piggyback from the service chamber when the clamp band is removed (Fig. 44).

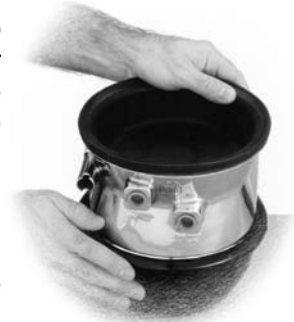
Figure 48

Place a new diaphragm into the cavity of the single/piggyback chamber flange case (**Fig. 48**) and align the single/piggyback with the non-pressure chamber.

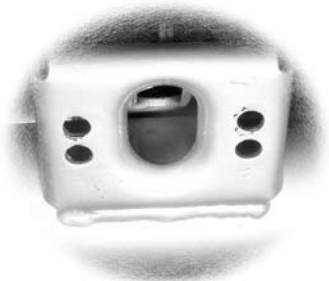
Figure 57

Remove the hex nuts and the flat washers from the mounting bolts of the new chamber. Prior to installing the new combination/tandem brake, take a few minutes to inspect the mounting bracket to insure the bracket surface is free of all cracks, burrs and debris that may prevent the brake from mounting flush to the bracket's surface (Fig. 57).

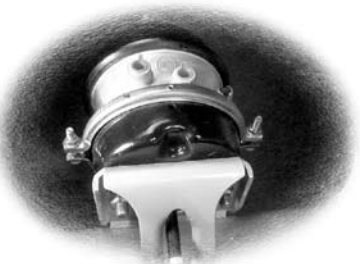
Figure 58

Now, install the new chamber on the bracket, paying close attention to positioning the chamber air inlet ports for correct alignment to the vehicle air supply lines (Fig. 58). **Make sure you mount the brake directly to the bracket. DO NOT use any spacers, washers or shims between the mounting bracket and the non-pressure housing.** Install one flat washer and hex nut on each mounting bolt, and, using a 15/16-inch hand wrench (**DO NOT USE AN IMPACT-TYPE WRENCH**), tighten the nuts to the MGM Brakes recommended 133-155 Lbs.-Ft. of torque (Fig. 59).

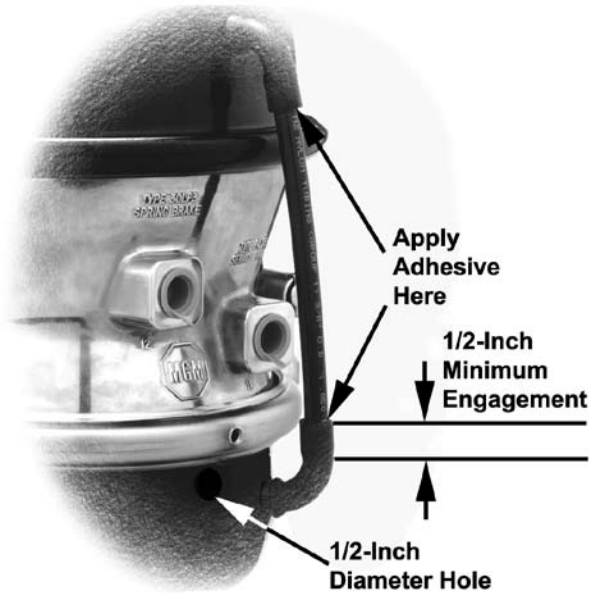
Figure 69

If the chamber is fitted with an external breather tube, be sure both ends of the tube are engaged a minimum of 1/2-inch into each of the flexible rubber elbows (**Fig. 69**). The tube must be securely fastened into both elbows, either by applying a high-quality rubber adhesive or with hose clamps.

NOTE: IMPORTANT - When installing any MGM Brakes model with the breather tube, it is mandatory to position the breather tube in the upper half, or upper quadrant (9:00 to 3:00 o'clock), facing away from the road surface (Fig. 60). Failure to comply will void the MGM Brakes Warranty without remedy on these models.

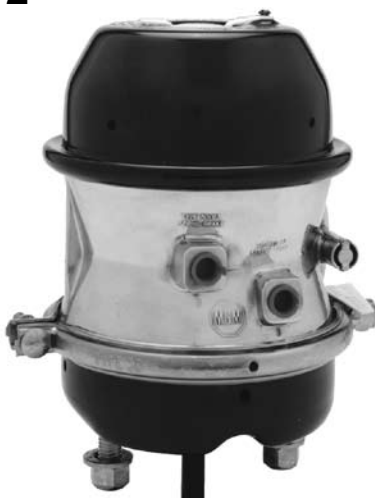
Figure 76

Elevated brake temperatures are a major factor in the loss of braking effectiveness. We have seen how stopping distances were adversely affected by the increase in stroke caused by improper brake adjustment. Now, consider the increase in stroke brought on by the heat-induced expansion of the brake drum. If the temperature of the drums on the same test vehicle were raised to a realistic operating temperature of 600° F, the stopping distance would increase to approximately 692 feet, even though the brakes were adjusted to the CVSA limit.

You can see that even though the brakes were technically “in adjustment”, the influence of heat on the chamber stroke, in conjunction with normal brake lining fade, more than doubled the stopping distance. That is why 3-inch “Long Stroke” brakes (**Fig. 76**) have become one of the hottest topics in the trucking industry today. The bottom line for the use of “Long Stroke” brakes is safety. Even with proper maintenance and the incorporation of automatic slack adjusters, vehicles equipped with standard (2.5-inch) stroke chambers can still suffer a loss in braking performance. MGM Brakes, along with the American Trucking Association, the National Highway Traffic Safety Administration (NHTSA) and other industry leaders have worked very closely with CVSA on the “Long Stroke” concept.
